Detailed Drainage Plan and Terrain Stability Assessment
Winlaw Woodlot
Proposed Silica Mine Forest Road
Winlaw Creek
Map reference 82F070,80

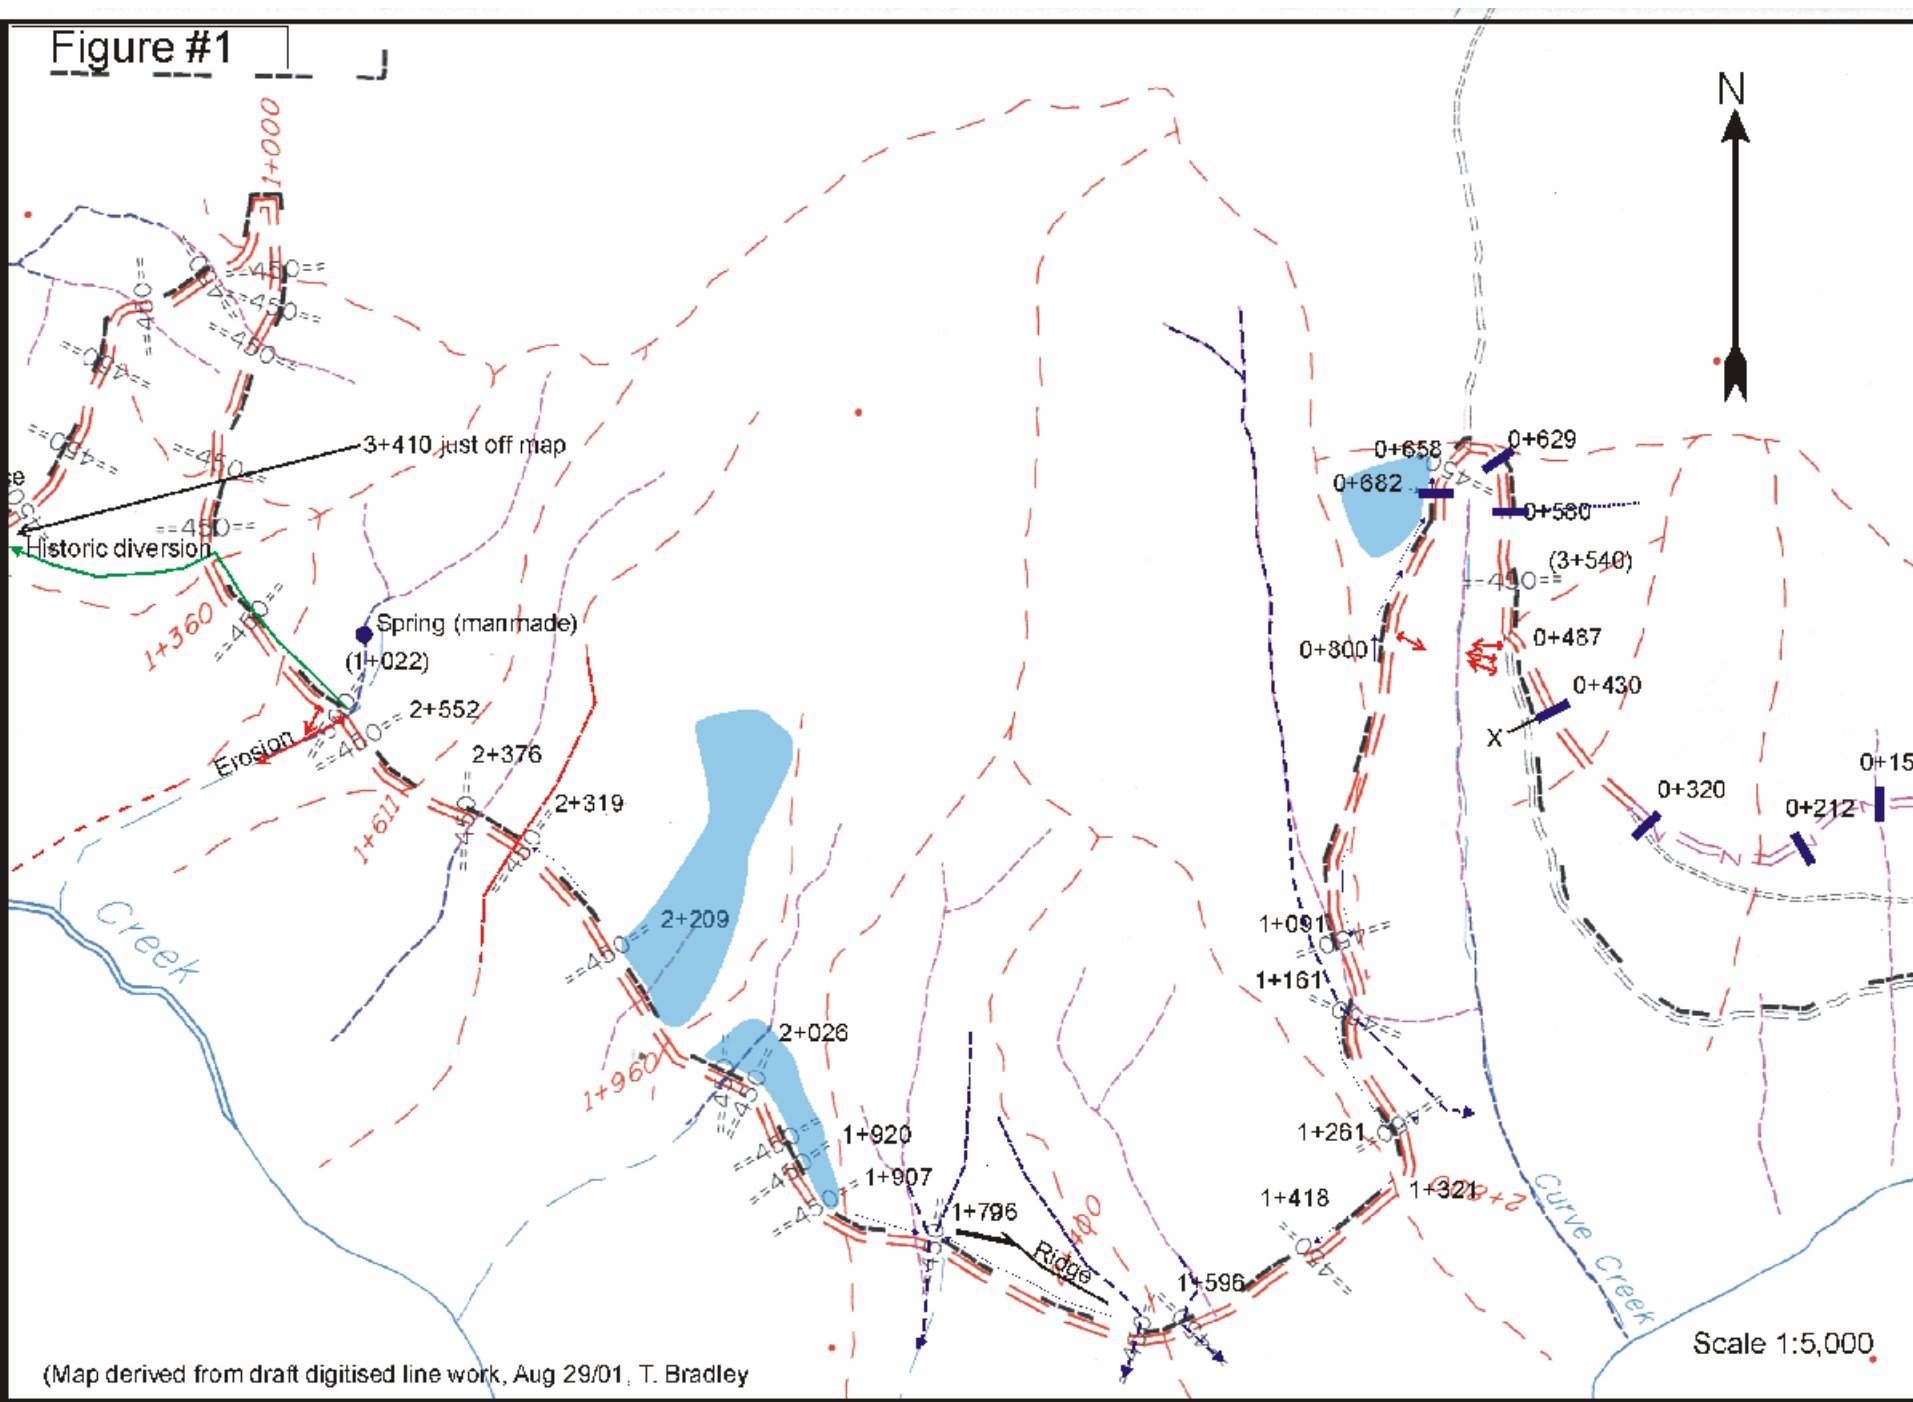
Figure #1

Observations are summarised in table 1 in the appendix and figure 1.
