Detailed Drainage Plan and Terrain Stability Assessment
Winlaw Woodlot
Proposed Silica Mine Forest Road
Winlaw Creek
Map reference 82F070,80

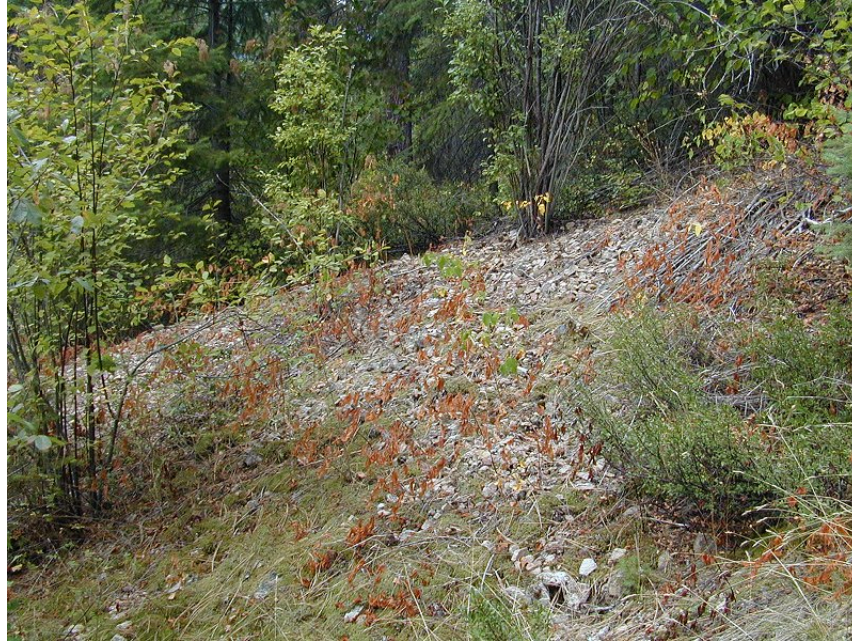
6. The very large "slide" that occurred in 1971 at the corner at 3+410 is an erosion gully caused by the diversion of the stream at 2+552.

The large slide/erosion scar at 3+410 is a significant feature and stakeholders have concerns that the slide could be retriggered by additional development. As a result of this concern the feature was investigated to determine the cause and mechanism of formation. Features on the ground indicate that the feature was formed by erosion caused by the diversion of the stream at 2+552. The likely sequence of events that caused the erosion can be determined by features noted on the ground. The small bowl in which the drill hole was located has a fairly large catchment area. The drill intersected an aquifer below the ground water flow. The water flowed up through the drill hole and pooled in the bowl. It is likely that there was some sort of barrier such as a pile of debris that restricted the water from flowing out of the bowl or that there was a significant increase in the rate of flow from the flow significantly increased out of the drill hole (the drill hole casing may have been capped originally and then the cap was removed) it may have been capped). It appears that there was a short duration very high flow perhaps caused by breaching the barrier (dam burst). The water flowed down the cat trail that was constructed to service the drill pad. Scour from the dam burst event eroded the road bed to cobble sized material (this road bed is now a stream channel). The water was then deflected down the Silica Mine road. There is evidence of extensive scour along the road. There are a number of areas where water flowed off the road and deeply eroded the fillslope and down slope areas depositing cobble cones on lower trails and slopes. Photo #1 below shows a cone that completely covers an old trail. There are numerous old slides and erosion features below the road that appear to be about 30 years old, suggesting that all the features occurred in a relatively short period of time. At first most of the flow was diverted to 3+410 resulting in the large erosion gully ("slide") in a sandy gravel terrace.

The large slide/erosion gully at 3+410 is an erosion feature that was a result of unique circumstances. There is a low likelihood of a repeat of the events which caused the erosion. With the exception of minor raveling from the steep headwalls, the area is stable. There is no need to re-align the road.
